20th Annual International Symposium
October 24-26, 2017 • College Station, Texas

Analysis of Leak and Explosion from an Underground Pipeline in Kaohsiung, Taiwan

Hui-Ning Yang, Jen-How Chen, Home-Jo Chiu, Ting-Jia Kao, Hsiao-Yun Tsai, and
Jenq-Renn Chen*

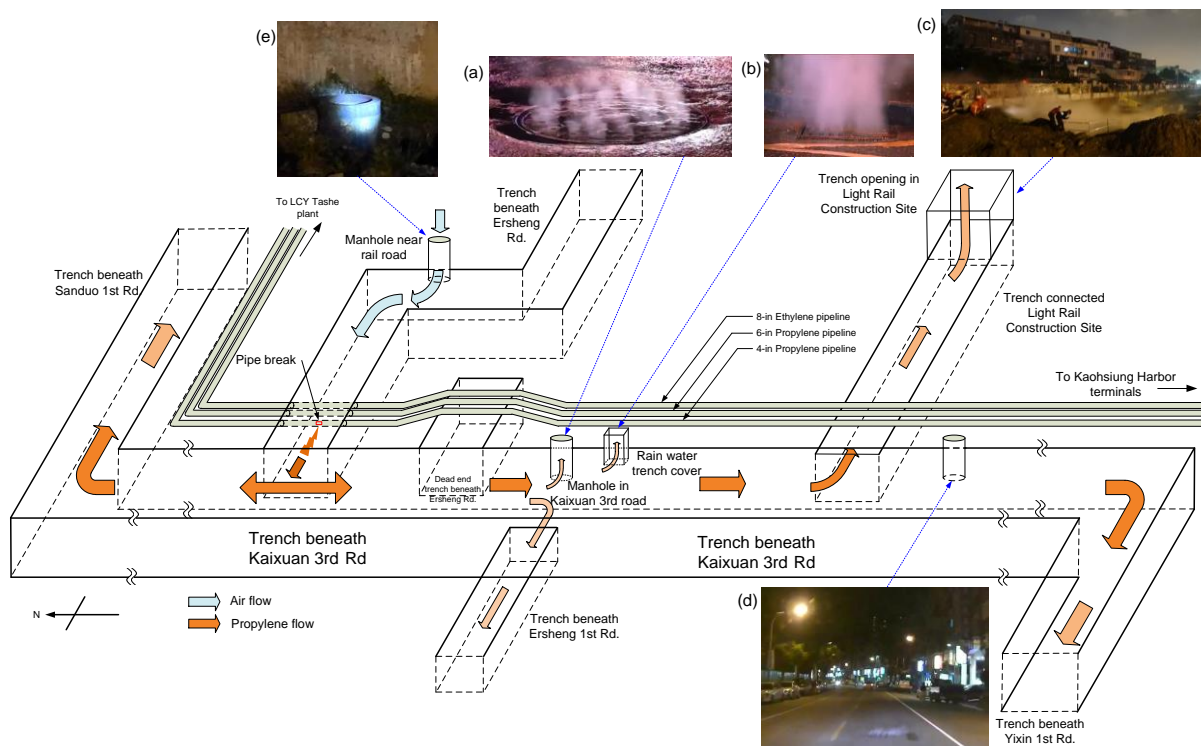
The incident was first reported from an unknown fog to come out intermittently from roadside rainwater trench covers and manholes of the storm trench beneath the junction of Ersheng 1st Road and Kaixuan 3rd Roads in downtown Kaohsiung City on 20:46 July 31st 2014, as shown in the inserted photos (a), (b) and (d) in Figure 1. Fire fighters from Kaohsiung City Fire Bureau reached the site on 20:50, secured the area and began spraying water on the fog. An incident command post was also setup in the foot path of the road junction. Efforts were made to identify the leak materials and leak source but were unsuccessful. While the fog erupting from manholes of the storm trench beneath the junction of Ersheng 1st Road and Kaixuan 3rd Roads diminished gradually, a small explosion in the manhole of storm water trench occurred about 1 km away from the initial leak scene on 22:20. The explosion however did not escalate. Around 22:50, a major white smoke was found coming out from a nearby light rail construction site underground trench opening as shown in the inserted photo (c) in Figure 1. This opening was then considered as the source of the leak and the site was considered as the hot zone with restricted entry. Air samples were also taken back for analysis. Unfortunately, explosion occurred before the air sample was analyzed. Another peculiar and unresolved finding at 23:45, right before the explosion, was an intermittent suction or flowing sound from a manhole near the railroad as shown in the inserted photo (e) in Figure 1. There was however no vapor eruption from this manhole. Thus, there was no clear conclusion regarding the leak gas, the leak source and the source owner before the explosion. Formal confirmation of the leak gas to be propylene was delayed to 6:30 am the following day by residual gas on the intact storm water trench in Ersheng 1st Road. Figure 1 shows the schematic diagram of the pipeline, underground trench, the spread of the leak vapor and corresponding photos for the vapor eruption at different locations.

Figure 1: Schematic diagram of the pipeline, underground trench, the spread of the leak vapor and corresponding photos for the vapor eruption at different locations.

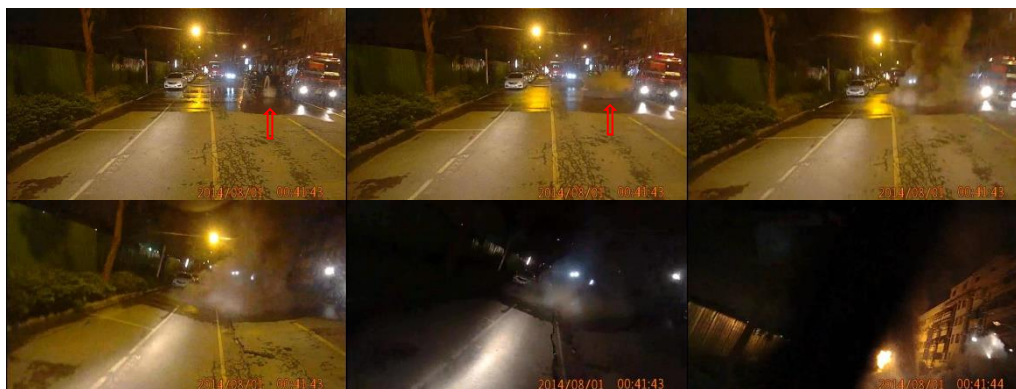
Without any warning, an explosion occurred near the command post on 23:57 July 31st. The explosion was occurring beneath the road surface with a smoke erupting out from the storm water trench manhole, followed by road surface crack, and a large fire erupted out. Figure 2 shows a sequence of frame from a recorder on a fire truck. The arrow in the first frame indicates the first smoke eruption from the manhole. The road surface was blown out and pushed upwards all vehicles and personnel on the road and then collapsed to the trench. The fire truck in Figure 2 was eventually turned upside down.

Figure 2: Sequence of explosion recorded on a fire truck in Kaixuan 3rd road facing south bound.

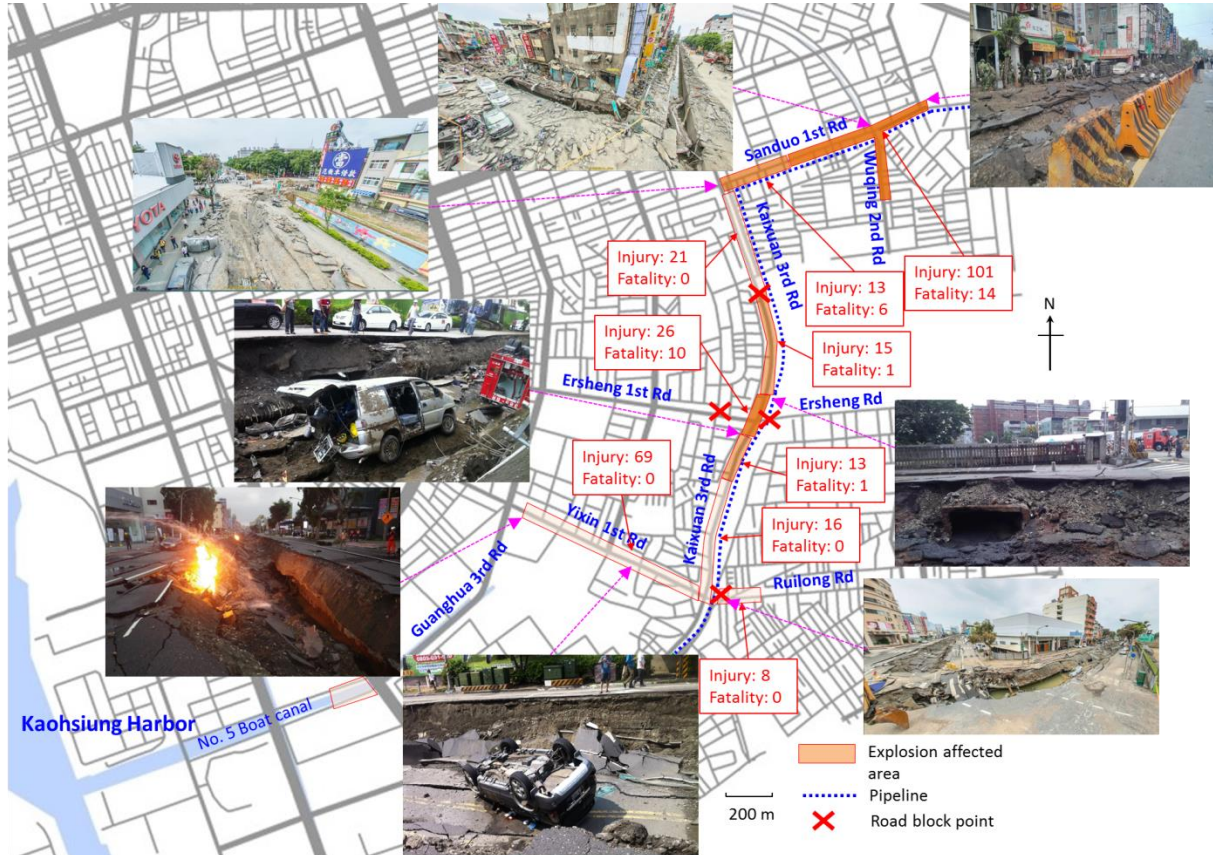
Figure 3 shows the pipeline route, the explosion affected area, the distribution of casualties, and corresponding photos for damages. The explosion propagated along the Kaixuan 3rd road to the north and south along the storm water trench. At the north end of Kaixuan 3rd road, the explosion propagated towards Sanduo 1st road and its junction to Wuqing 2nd road. A total of 4.5 km road were blown out.

The junction of Sanduo 1st road and Wuqing 2nd road suffered the largest fatalities and injuries as indicated in Figure 3. Wuqing 2nd road is famous for many midnight snack shops. A surveillance video showed that there was a red light stopping several cars and scooters right before the explosion. Another factor contributed to the significant fatalities in this area is that the road surface covering the storm water trench was only about 0.5 m which is very thin comparing with the 1 ~ 2 m in other roads. The explosion not only blew out the road surface but also shattered the road into small fragment and debris. Some of the debris was even blown up to the roof of four-floor houses as seen in Figure 3. Casualties were mostly caused by the debris impact and the explosion flame. The explosion on the Sanduo 1st road eventually diminished about 400 m east from the junction of Wuqing 2nd road.

The second largest fatalities were occurred in the junction of Kaixuan 3rd road, Ersheng road and Ersheng 1st Road which centered on the incident command post. Fire trucks that parked on the Kaixuan 3rd road were overturned by blown out road as shown in Figure 3. More than twenty fire trucks were damaged. Most fire fighters stayed near the fire trucks were injured or buried by the debris or the overturn fire trucks. Seven of the ten fatalities on this road junction were fire fighters. The explosion damage on the south side of Kaixuan 3rd road and Yixin 1st Road was less severe compared with other area as shown in Figure 3. It is likely that most explosion energy was dissipated by the thick road surface on top of the storm water trench. Vehicles remained intact even

Figure 3: The pipeline route, the explosion affected area, the distribution of casualties, and the corresponding photos for damages.

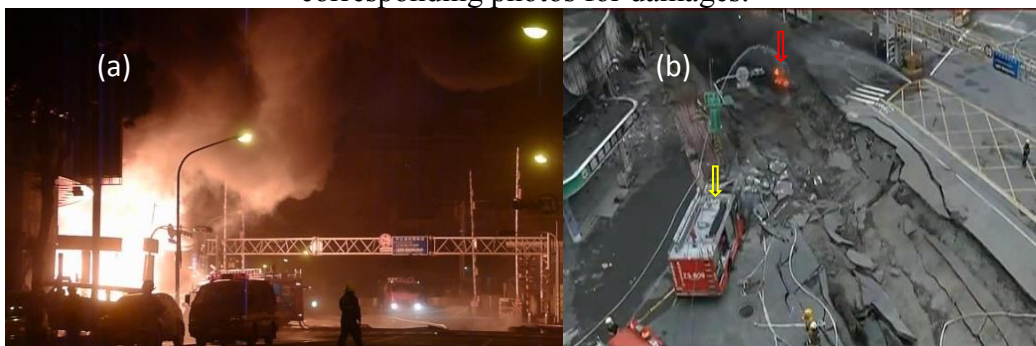
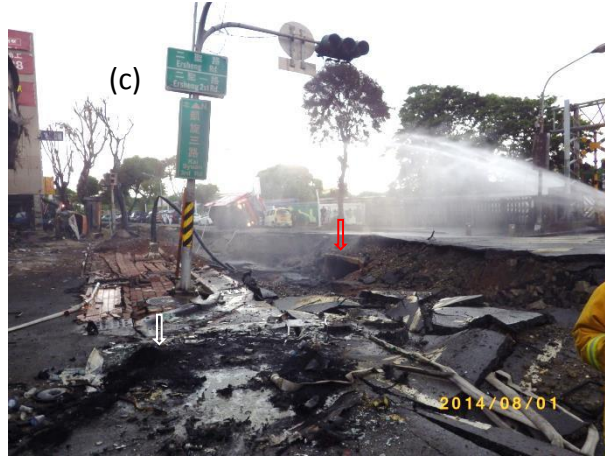
Despite the complicated leaks and silence of the pipeline operators, the identification of the leak source after the explosion was straightforward without ambiguity. After the explosion, a large jet fire developed near the junction of Ersheng 1st Road and Kaixuan 3rd Road as shown in Figure 4(a). This was the largest fire after the explosion and it lasted till 6 am the following day. As the fire diminished gradually, it can be seen clearly that the fire was coming out from a branch of storm water trench as indicated in Figure 4 (b) and (c). Clearly, this would be the source of leak.

As the area were blocked for traffic, the only available ignition sources were the fire trucks which remained running to provide firewater. In fact, there was a fire truck near the junction of Ersheng 1st road and Kaixuan Road as shown in Figure 4(b). The engine of the fire truck after the explosion

was completed burnt down, yet Figure 4(c) showed that the road sign in front of the engine remained intact. Thus the fire on the fire truck engine was unlikely to be caused by the jet fire from the leak pipeline. Figure 4(c) also showed the char from burnt fire truck tire after the removal of fire truck. The white arrow in Figure 4(c) was the location of a telephone cable junction box cover. The telephone cable junction box is not sealed but usually drained to nearby storm water trench. It is very likely that the vapor in the storm water trench spread out into the junction box, and eventually escaped the cover to meet the truck engine and ignited. The ignition resulted in flame propagation and explosion along the storm water trench with smoke eruption from the trench manhole. With flame accelerated along the trench, the explosion intensity also increased. Eventually the road surface blew out with erupted flame. The explosion propagated through the entire trench that filled with flammable vapor.

Figure 4: Photos of the fire after the explosion on the north side of junction of Kaixuan 3rd road and Ersheng 1st road. Time of the photos: (a) 12:00 am (b) 06:00 am (c) 07:05 am. Red arrow indicates the location of storm water trench branch with the leaked pipeline. Yellow arrow indicates the fire truck engine suspected to be the ignition source. White arrow indicates the char from burnt fire truck tire. Note for the road sign in front of the engine remained intact.

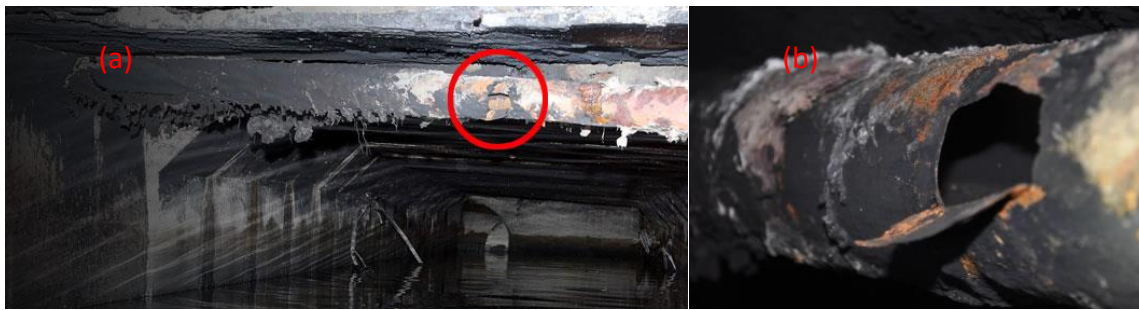
Subsequent inspection of the trench branch with jet fire revealed that there were three pipelines passing through the trench. The 4-in line was completely exposed in air and had a break opening of 4 cm by 7 cm as shown in Figure 5. The 6-in and 8-in lines were located next to the 4-in line, partially exposed in air, and remained intact. These two pipelines did not suffer the jet flame impingement from the 4-in line as they were located on the back side of the 4-in line opening. Inspection of the leaked pipeline also showed pipeline wall thickness greatly reduced from its original 6 mm to less than 1 mm by corrosion from the humid ambient environment in the trench. Thus, it is concluded that it was the LCY 4-in propylene pipeline leaked and caused the explosion.

Figure 5: Photos of (a) the storm water trench, the 4-in propylene pipeline and the break, (b) close view of the break opening.

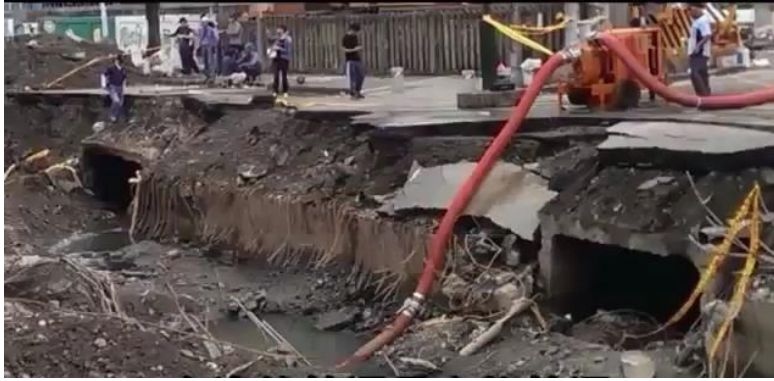
It is important to know how the leak in the trench was spread such that responders may take proper action in future incidents. Investigation revealed that there were two storm water trench branches as shown in Figure 7, one being directly beneath the Ersheng Road but is only 7 m in length and sealed in the other end, the other being about 10 m north of the dead ended branch and housed the pipelines. The later was then connected to the trench beneath Ersheng Road. We put up a schematic diagram in Figure 1 showing all the trenches and trench openings. The trench branch that housed the pipeline had a manhole upstream which was the manhole with the suction sound. As the pipe break was facing towards the main trench, the leak from the break would form a jet and entrained significant air from the upstream trench. The direction of the leak is thus in consistent with the finding of suction sound in the upstream manhole. It is also consistent with the fact that there was virtually no damage in Ersheng road. The vapor jet impinged on the trench beneath Kaixuan Road and spread in both direction regardless of the trench sloping as shown in Figure 1. The vapor flow was completely different from a liquid leak which would flow by gravity. The spread of the leak vapor in the underground trench was governed by the flow resistance which is in turn affected by trench size, branched flow and trench opening to ground. Branch flow is in general much smaller than line flow in a tee junction. Flow into a larger branch is also favored over a small branch. Finally, the area with most vapor escaped do not necessarily corresponds to the leak source but rather depends on the size of opening to ground. These findings will be useful for all incident commanders dealing with underground pipeline leak incidents provided that all underground trenches are well documented and available during the incident.

Figure 7: Photo of the storm water trench branches, the left one housed the pipelines and the right one was sealed in the other end with a total length about 7 m.
